Manhole Inspection Summary

Manhole # S29M__015MH

Insp Date: **5/21/09 12:02 PM**

Location Address: **1004 CROSS-WYETH-ALLEY**

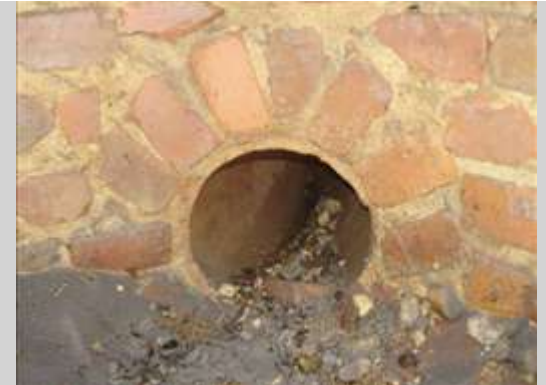
12 O'Clock Outflow

8 in. Circular Gravity Sewer
Pipe Out @ 12 O'Clock

Pipe Height: **8.4** (in.) Rod and Bar (Angled)

Pipe Material: **Clay** ☐ Pipe Lined

Infiltration: **None** Pipe Seal Cond: **Sound**
